BLACKSTONE RIVER BASIN
AUBURN, MASSACHUSETTS

PONDVILLE DAM

MA. 00197

PHASE I INSPECTION REPORT
NATIONAL DAM INSPECTION PROGRAM

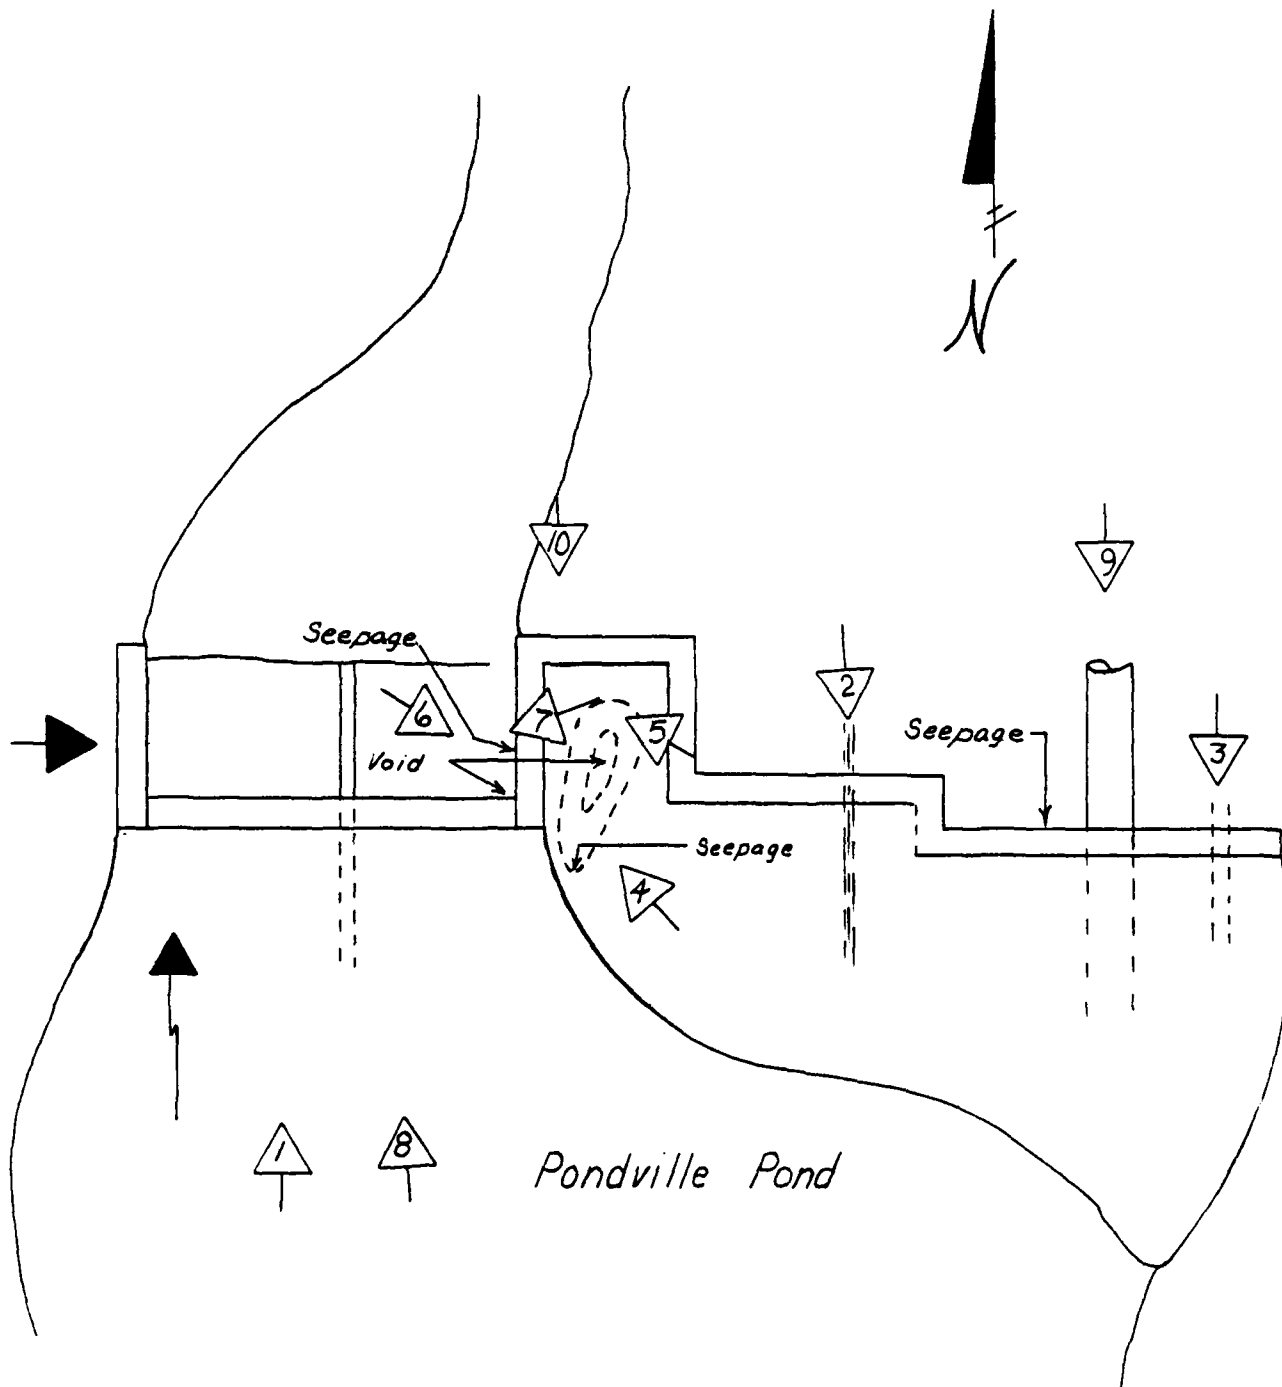
2. Downstream view of left 6 in. dia. pipe extending from downstream face of dam. (Photo taken 24 Oct. 1980)

p.17 R 7.2	Add recommendation to investigate seepage at pipes.
